Introduction of corralones, (semi-roofed shelters) and veterinary pharmacies in order to protect livestock (Llama camelids) and reduce mortality due to extreme events in the Bolivian Altiplano (High Andean Plateau).

Description of the application of the technology/practice

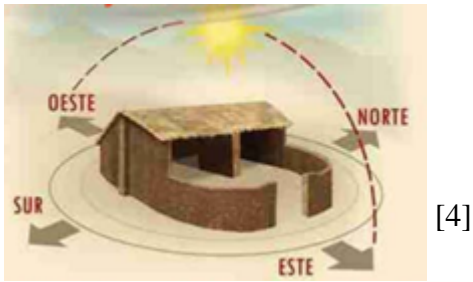
[4]

The entrance of the *corralón* should face the sunrise (east) in order to warm up and disinfect the shelter.

Photo 1. Orientation in relation to the sun

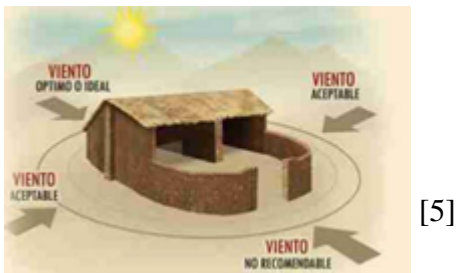
[5]

The back of the *corralón* should face the direction from where the strongest and most frequent winds blow.

Photo 2. Orientation in relation to the wind

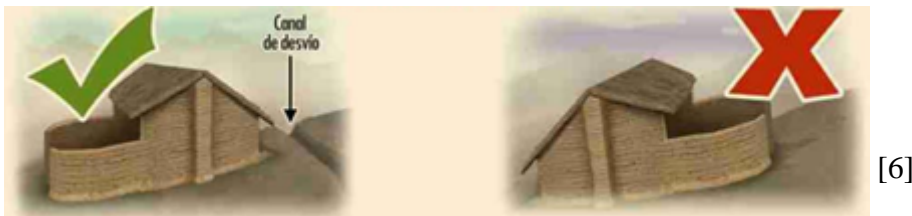
[6]

When built on a slope, the *corralón* entrance should be oriented facing down the slope, and a water-diversion canal should be dug in the upper side, at the back of the *corralón*.

Photo 3. Orientation in relation to the topography

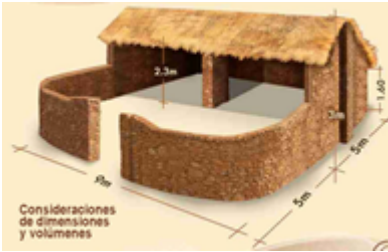
[7]

A shelter of $9 \times 5 \text{ m}$. is enough to fit 30 adult llamas, covering a surface of 45 m^2 .

Photo 4. Corralón dimensions

The dimension of the *corralón* is directly correlated to the size of the herd, with a ratio of 1.5 m^2 per adult llama. It is advisable to also consider the amount of pregnant female and baby llamas.

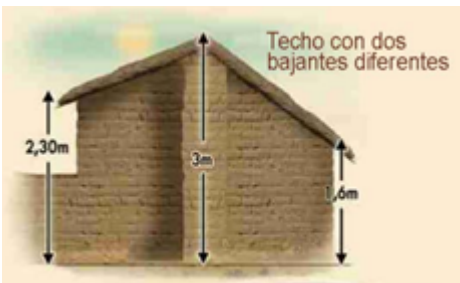
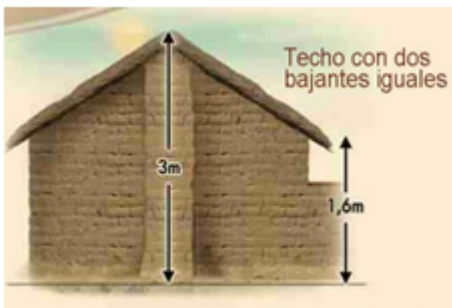
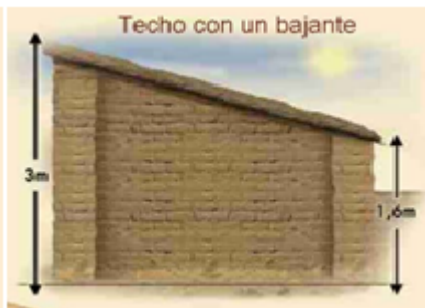
[9]

The roof of the shelter could be of one or two gabled roofs. When designing the roof, considerations on the maximum high of llamas (1.70 cm) should be taken, being recommended to have a maximum high of 3 m.

Photo 6. Ceiling design

The roof may vary in thickness, and may be composed by one material or by the combination of different materials, such as straws, roof tiles, bamboos, mud, plastic membranes, weaved wires, etc.

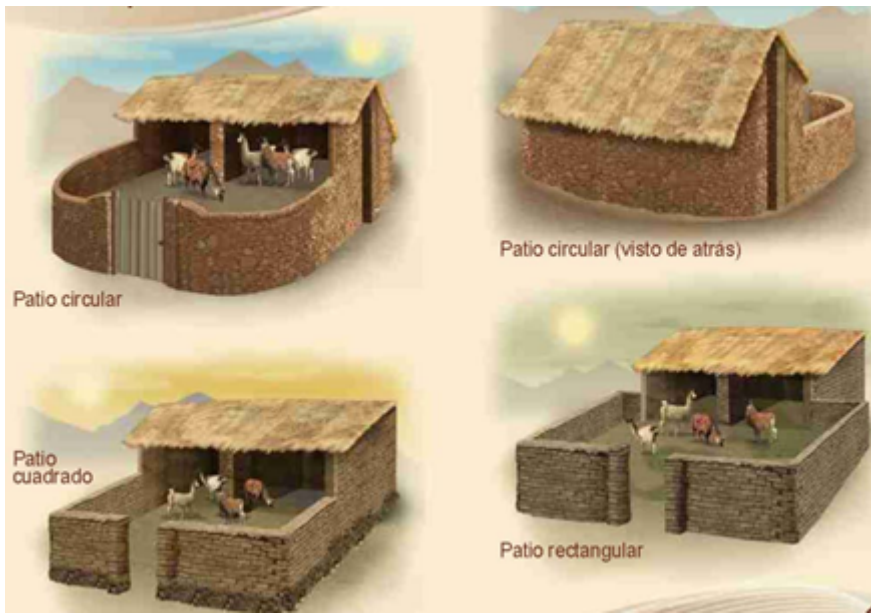
[10]

As a general rule, the area of the patio is the same as the area of the shelter, but may vary according to the availability of space.

The shape can be circular, rectangular or squared. Although it is recommended for the patio to have a rounded shape, in order to facilitate cleaning as well as to facilitate the movement of the llamas and a safe management.

Photo 7. Patio design

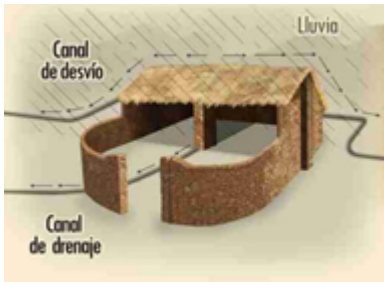
[12]

In laden terrains a construction of a water-diversion canal in the upper side of the *corralón* is needed to deviate rain water.

To drain out the urine and any rain water that filters into the *corralón*, in order to maintain it dry.

Photo 8. Water-diversion and draining canal

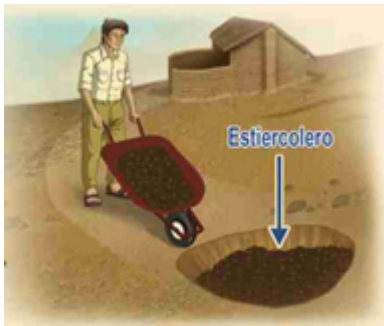
[13]

In order to maintain clean the *corralón*, while facilitating the production of manure.

Photo 9. Dung deposit

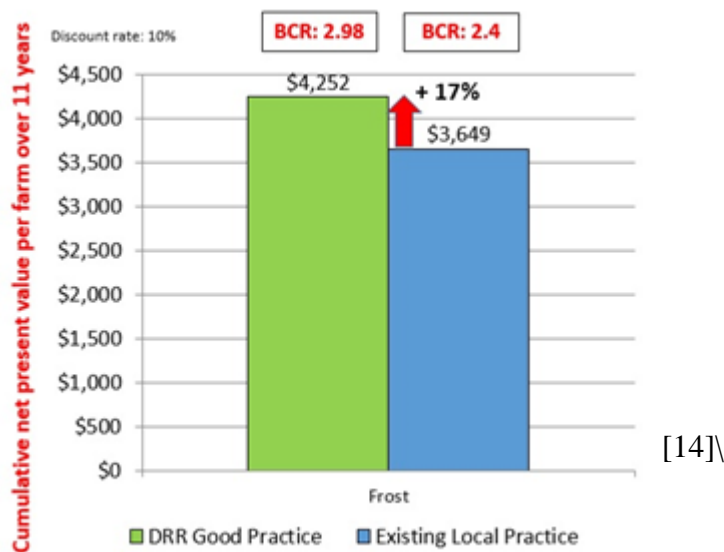
Figure 1 provides an overview of the outcome of the CBA. In particular, it shows that:

- The good practice brings 17 percent higher net benefits as compared to the usual practice.
- The BCR of the good practice (2.98) is higher than the BCR of the local practice (2.4), meaning that the good practice brings greater benefits relative to costs, as compared to the usual practice.

Figure 1. Cumulative Net Benefits and Benefit Cost Ratio of DRR Good Practice and Existing Local Practice

Cost-Benefit Analyses (CBA) were conducted based on quantitative data collected during the 2016 winter period. The net benefits obtained from raising camelids with *corralones* and veterinary pharmacies were compared to the net benefits of raising camelids without *corralones* and veterinary pharmacies. The costs and benefits were calculated based on the average herd size in the monitored farms (i.e. 85 llamas).|

The CBA calculates the cumulative net benefits obtained by an average farm over a period of 11 years (10 percent discount rate is applied to express the future value of costs and benefits in present terms), as well as the benefit-cost ratio (BCR), which is the ratio between total discounted benefits and total discounted costs over the appraisal period.
